## Unified Command Shoreline Cleanup Endpoint and Sign off Process

South 4 Group Fire

Port Neches, Texas

Prepared by CTEH, LLC

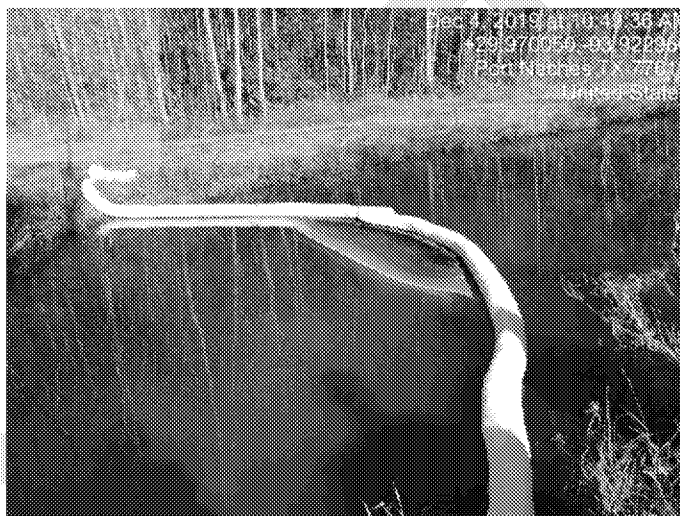
- Photo below, Division E just downstream of the pump station output, 12/4/2019 Sample (Z019) taken of material accumulated in boom shown in photo below, and referenced in the 12/4/2019 SCAT Daily Report. Results of the analysis for this sample have not yet been reported.

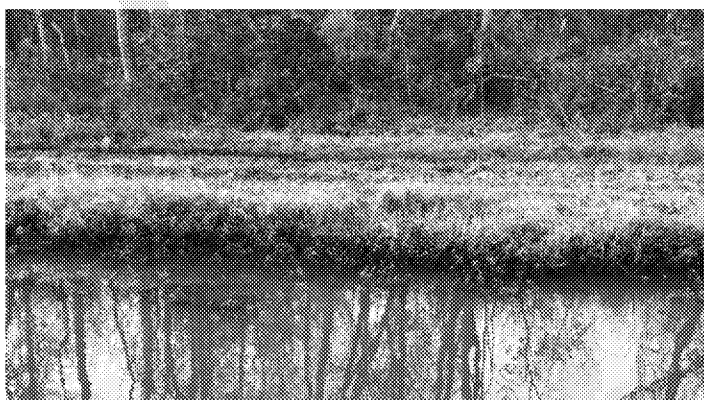
On 12/5/2019, the water level in Division E fell and exposed dark material, assumed to be mostly mud, on the shoreline vegetation. Some “streamers” of very light sheening was observed and possibly associated with the dark material as described in SCAT Daily Report(s). (See sampling section below)

- Photo below, Division E in area between the pump station and Atlantic Road, typical for entire area, 12/6/2019 Sample taken of dark material on vegetation (X016) shown in photo below and referenced in the 12/6/2019 SCAT Daily Report. The sample analysis intended to be representative of the dark material indicated the presence of hydrocarbon. A soil sample (S016) was also taken in this area. The results of the soil sample have not yet been reported.

In Division E, the dark material on the vegetation that became exposed when the water level fell (see photo in Section 3) is being flushed with a wash pump and collected in booms and recovered manually, and this is effectively removing the material and reducing the associated sheen.

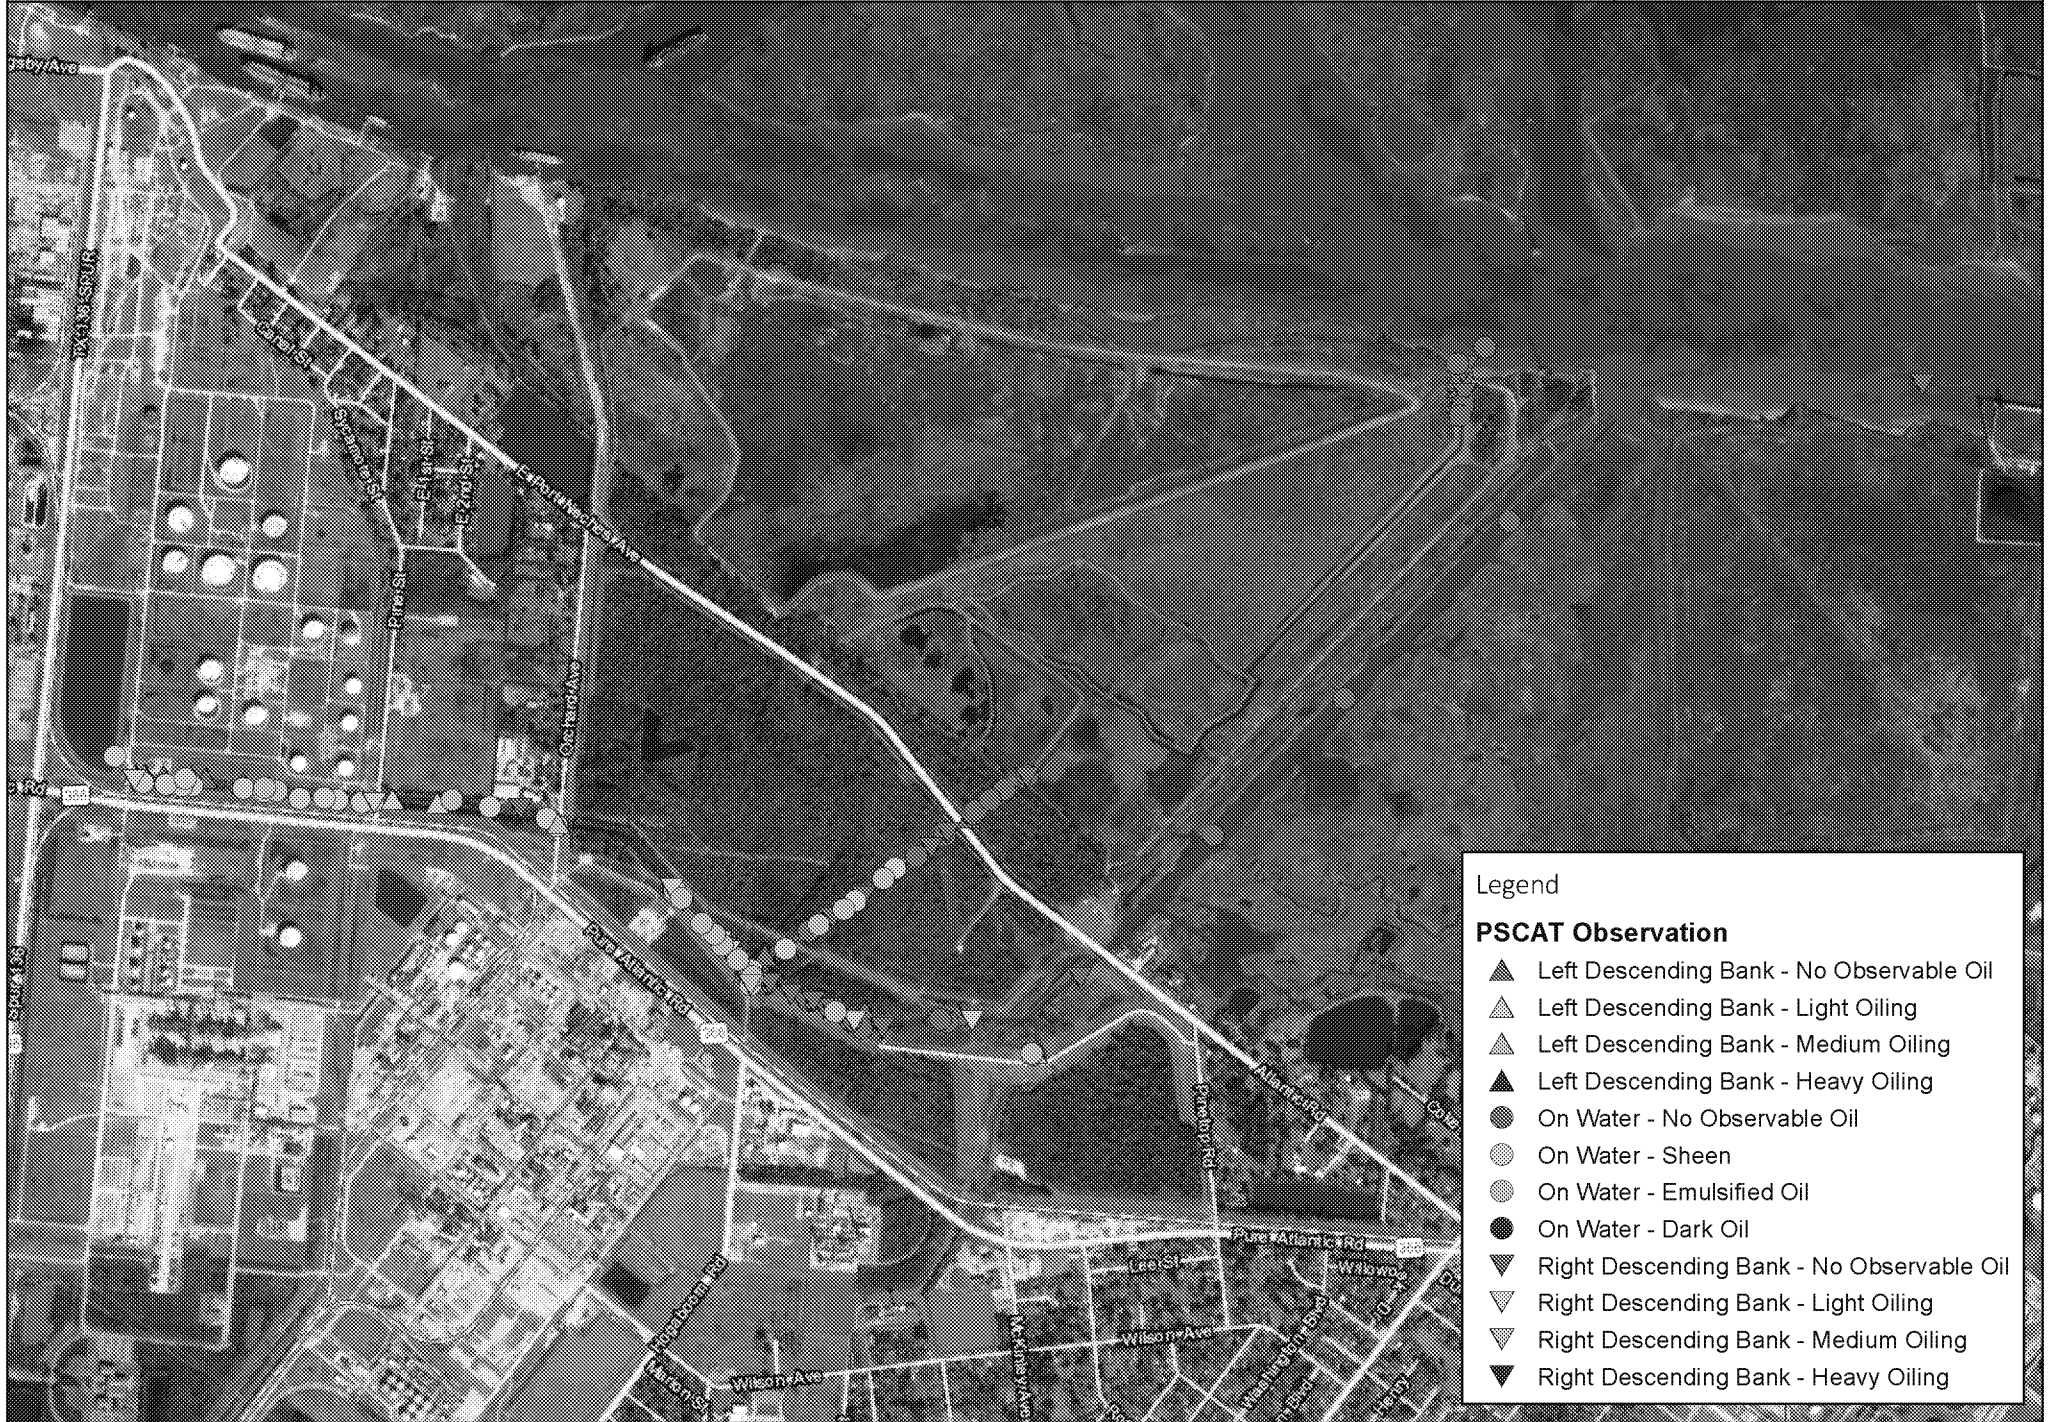
# Rapid Shoreline Assessment

Initial oiling in each division based on point observations on 12/2/2019 thru 12/5/2019 are depicted on the attached maps. Shoreline oiling conditions are described as light, and there was no heavy or pooled oil observed during the SCAT observations beginning on 12/2/2019. Access to view the shoreline on both sides of the canal of Division A and part of Division B is limited due to thick vegetation. There have been no observations of any heavy shoreline oiling. The most significant amount of shoreline oiled is in Division A. See below oiling summary as of 12/8/2019.
